NASA TM X-1266

EXPERIMENTAL EVALUATION
OF THROAT INSERTS IN
A STORABLE-PROPELLANT
ROCKET ENGINE

by Jerry M. Winter, Larry D. Plews, and James R. Johnston
Lewis Research Center
Cleveland, Ohio

NATIONAL AERONAUTICS AND SPACE ADMINISTRATION • WASHINGTON, D. C. • OCTOBER 1966

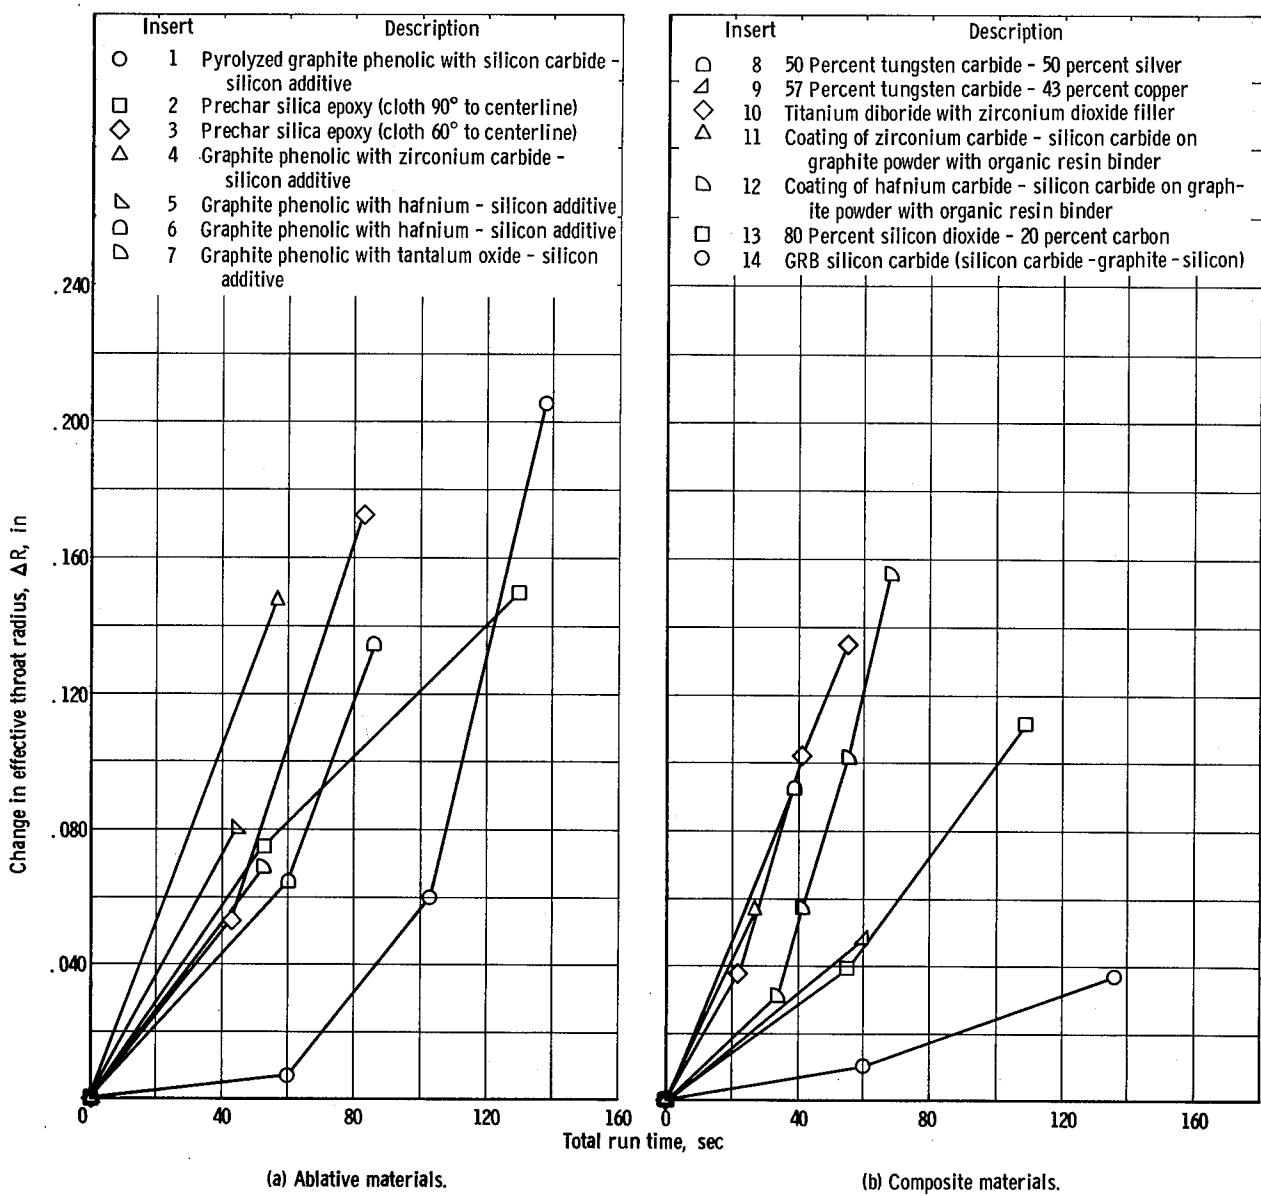
Figure 7. - Erosion of nozzle Inserts.

shown on figure 7(b). With the exception of the GRB material (insert 14), these erosion curves do not show a significant improvement over the ablative-material erosion shown in figure 7(a).

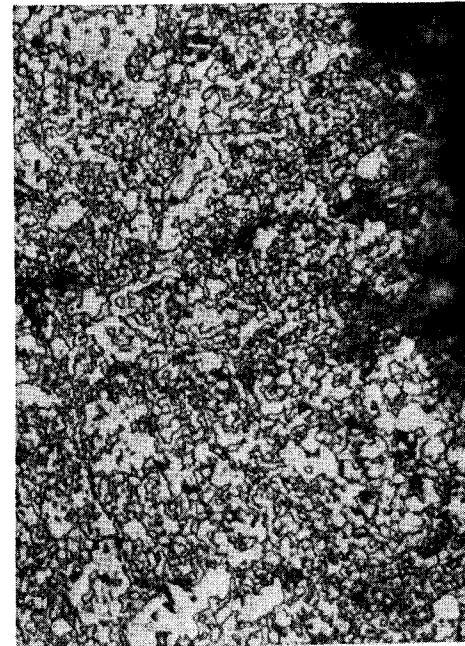
The apparent high degree of erosion of the tungsten carbide - silver insert (insert 8) compared with that of the tungsten carbide - copper insert (insert 9) was evidently caused by an inward radial distortion of the throat for the tungsten carbide - copper material caused by delamination and/or melting of the insert. Delaminations of the tungsten carbide - copper are shown in figure 8(a). The dark areas are voids running parallel to the nozzle axis. The gray areas are tungsten carbide particles in a copper matrix.

(a) Insert 9 (57 percent tungsten carbide - 43 percent copper).

(b) Insert 8 (50 percent tungsten carbide - 50 percent silver). X100.

Figure 8. - Photomicrographs of nozzle inserts 8 and 9 after firing. Unetched.

Figure 8(b) shows the microstructure of tungsten carbide - silver (insert 8). The voids are smaller and no cracklike alignment exists. The poor erosion resistance of both inserts 8 and 9 was due to rapid oxidation, melting, and mechanical removal of the weak metal matrix.

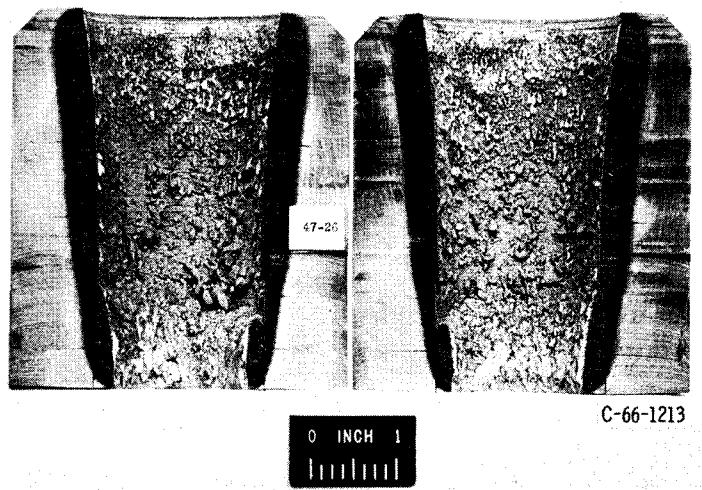
Figure 9. - Silica coating on nozzle insert 13 (80 percent silicon dioxide - 20 percent carbon) after firing.

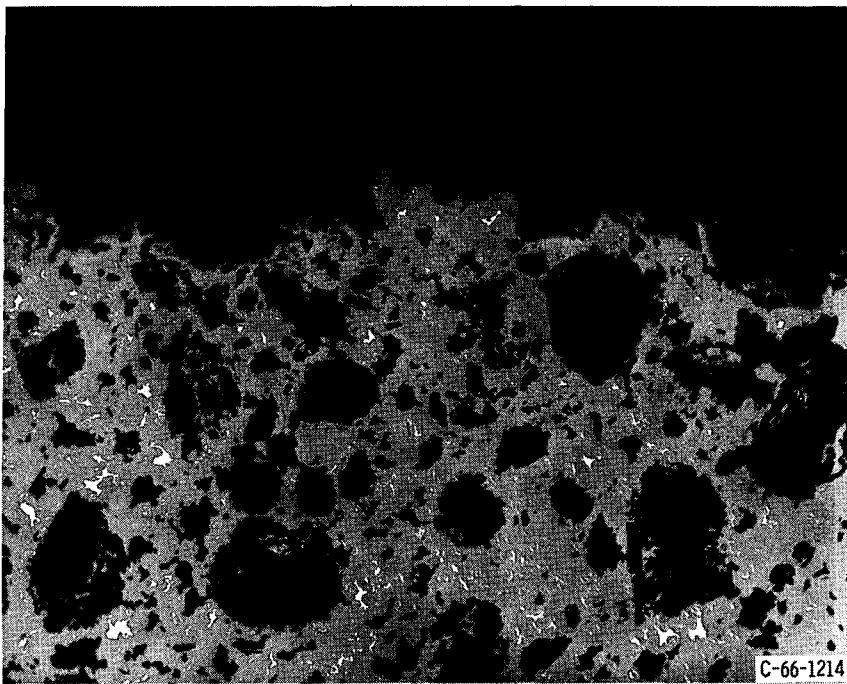
The GRB silicon carbide (silicon carbide - graphite - silicon) composite (insert 14) consisted of graphite and silicon particles in a silicon carbide matrix, as shown in figure 10. The purpose of the graphite particles was to prevent thermal shock cracking of the insert. In spite of the graphite, the insert failed by cracking during its second firing. Visual inspection of the insert following its initial 60-second firing indicated no cracking. While the erosion of the GRB insert was the lowest in its class, the structural failure prohibits its use in this configuration.

Figure 10. - Photomicrograph of nozzle insert 14 (GRB silicon carbide (64 percent silicon carbide - 33 percent carbon - 3 percent silicon)) after firing. Black particles are graphite; white particles are silicon; gray matrix is silicon carbide. Unetched. X75.

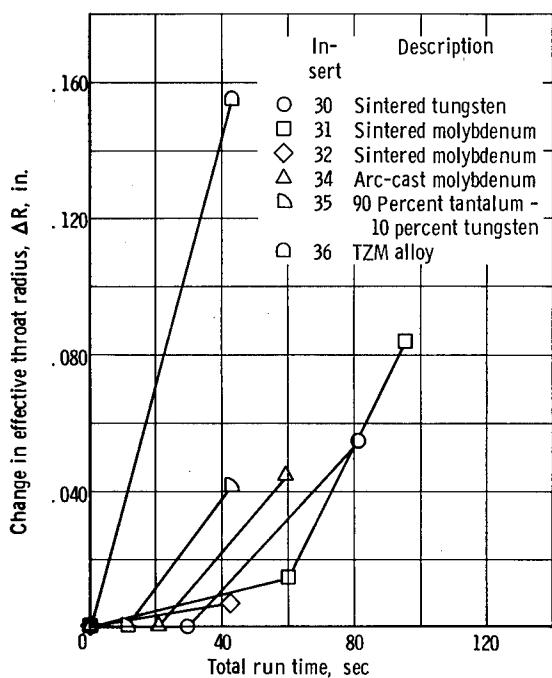
Figure 11. - Nozzle insert erosion of refractory metals and alloys.

The refractory metals and alloys generally were not suitable for the test environment. The niobium insert (insert 33) oxidized most severely of the 57 inserts tested and was almost completely consumed during the 17 seconds of testing.

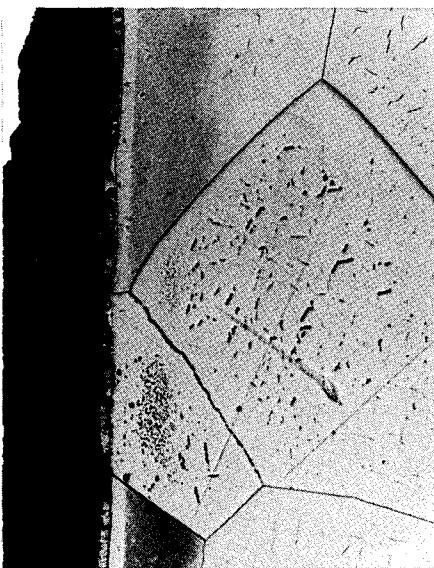
Dark glassy
layer

(a) Insert 30 (sintered tungsten). Etchant, 3-percent hydrogen peroxide solution. X250.

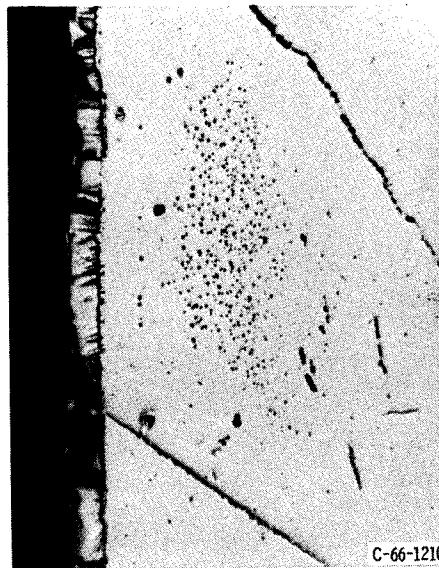
(b) Insert 36 (TZM alloy). Etchant, 5-percent potassium hydroxide - 5-percent potassium ferricyanide solution. X750.

are plotted in figure 11 for these inserts. Erosion due to oxidation was severe, particularly during the second test firing. The oxidation was frequently accompanied by severe gouging and the formation of a glassy deposit on the surface of the insert (see table I). Even in cases where throat erosion was relatively low, such as for the sintered molybdenum (insert 32), the severe oxidation at the upstream end of the insert indicated the need for redesign of the ablative-insert interface. No melting of the refractory metals was expected and none occurred. Figure 12(a), a photomicrograph of the sintered tungsten insert (insert 30), shows a recrystallized sintered tungsten with a dark glassy layer (believed to be amorphous silica) on the inside surface of the insert. Figure 12(b) shows the microstructure of TZM alloy (insert 36) after firing. A layer believed to be a nitride was found on the metal-gas interface of this insert.

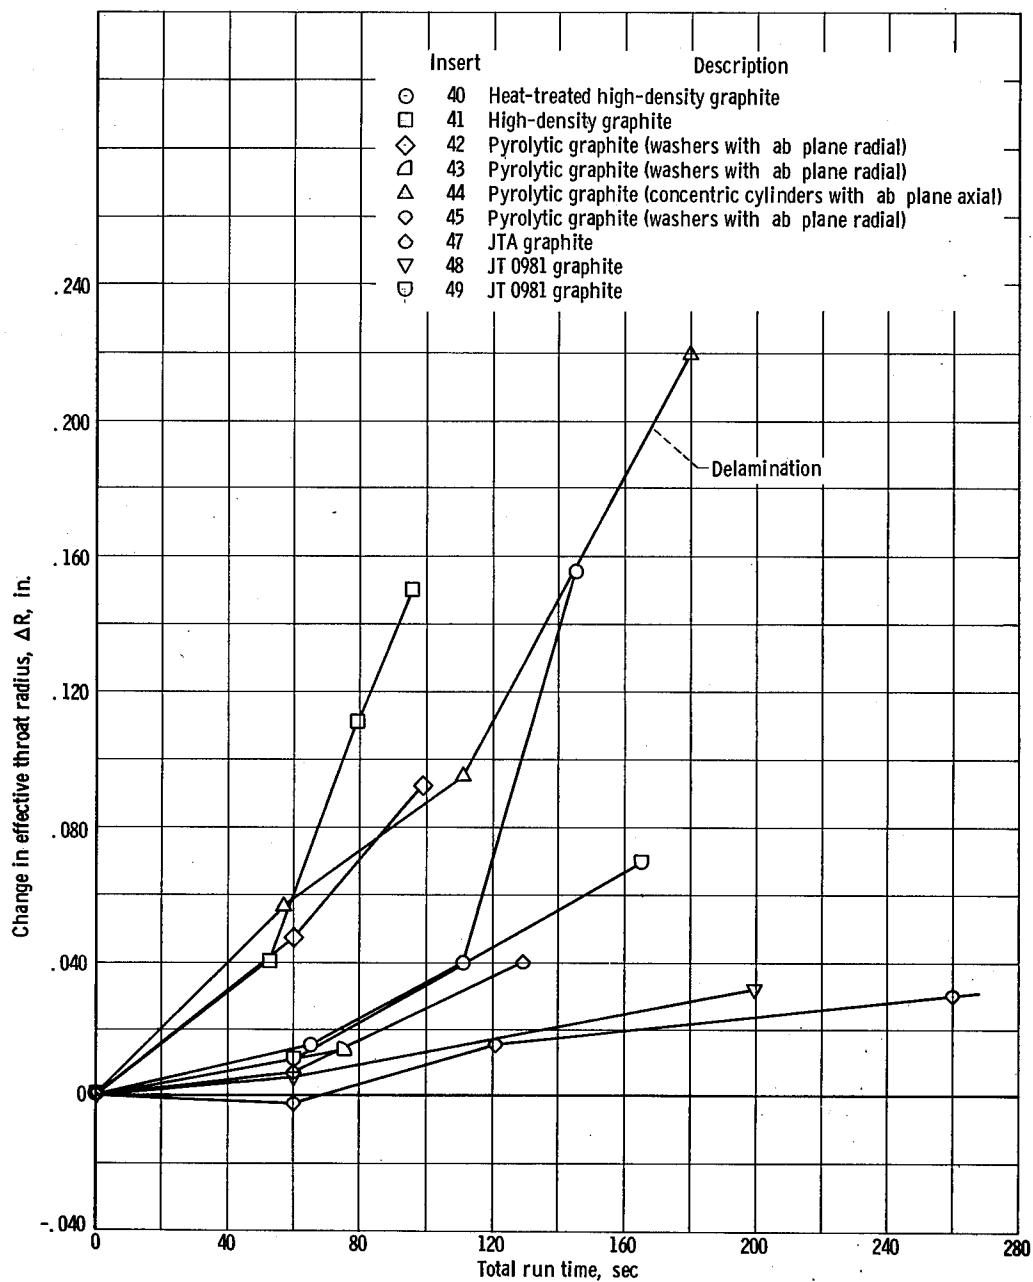
The graphites with additives were more erosion resistant than ablative materials and ATJ graphite, but they had more erosion than desired for an insert (fig. 14). The additives were expected to oxidize and to form a protective coating on the hot-gas surface of the insert during engine operation. Figure 15 shows the protective layer formed on the surface of the JTA graphite insert (insert 46) during firing. The dark area is graphite, the bright spots are zirconium diboride, and the wavy band is the protective layer formed by the reaction of zirconium diboride and silicon carbide with the combustion gas products. The coating was evidently not sufficient to prevent oxidation. A protective coating

Figure 14. - Nozzle insert erosion of graphite materials.

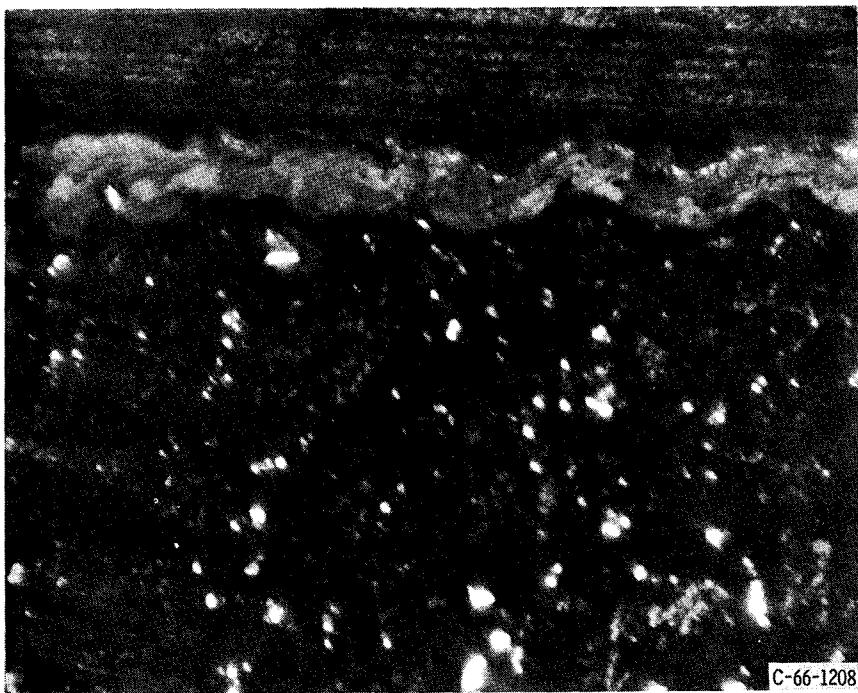
Figure 15. - Photomicrographs of nozzle insert 46 (JTA graphite) after firing. Unetched. X100.

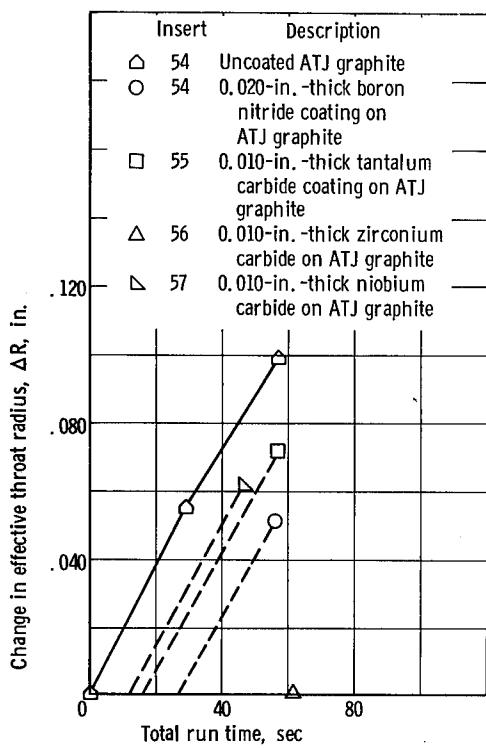
Both of the pyrolytic graphite coatings (inserts 52 and 53) failed and permitted

Figure 16. - Nozzle insert erosion of coated materials.

Insert 54 was tested after the coating was completely removed to determine uncoated ATJ graphite erosion. The unprotected ATJ graphite was found to have an erosion rate of 1.75 mils per second in the test environment. If no graphite erosion occurred until the coating was removed, it is assumed that the coatings protected the ATJ graphite for relatively short times, on the order of 10 to 30 seconds, for those coatings removed completely during firing.

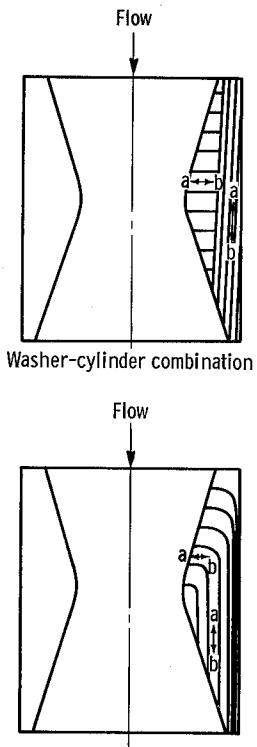
Figure 17. - Pyrolytic graphite nozzle inserts.

Pyrolytic graphite presents special design problems because of its unique properties. As was shown in an earlier section, pyrolytic graphite with the high-conductivity plane oriented radially provided good erosion resistance but caused the ablative envelope to melt (table I(45)). On the other hand, pyrolytic graphite with the high-conductivity plane oriented axially failed by delamination but kept the ablative char to a minimum (see

table I(44)). Two methods for combining these concepts are shown in figure 17. These designs would both be compromises between low erosion (oxidation), because they would keep the inside surface relatively cool, and protection of the ablative envelope, because they would insulate the outside diameter.

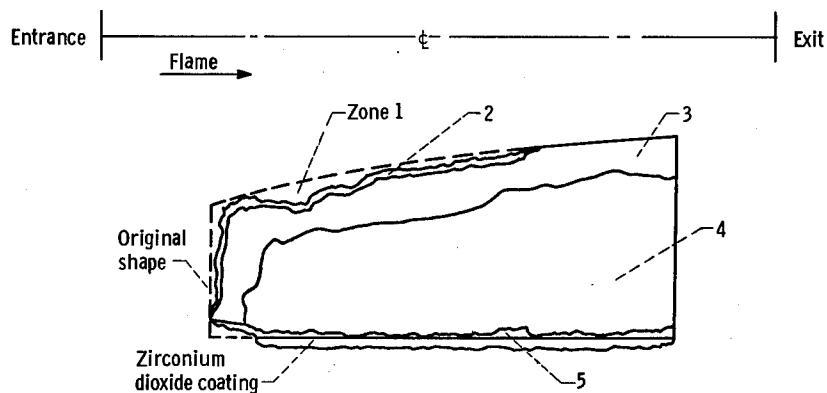
In Zone 3 the laminar tungsten had been recrystallized into an equiaxed structure.

Figure 18. - Cross section of nozzle insert.

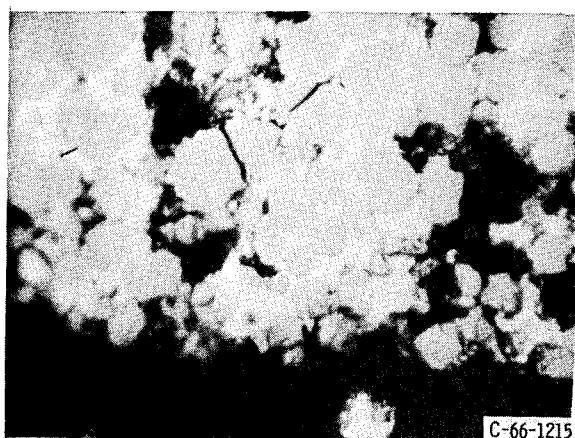
(c) Zone 4. X1600.

Zone 4 had areas of porosity produced from migration of the infiltrant into surrounding areas around the zone; however, these areas were small and did not constitute the major volume of the infiltrant.

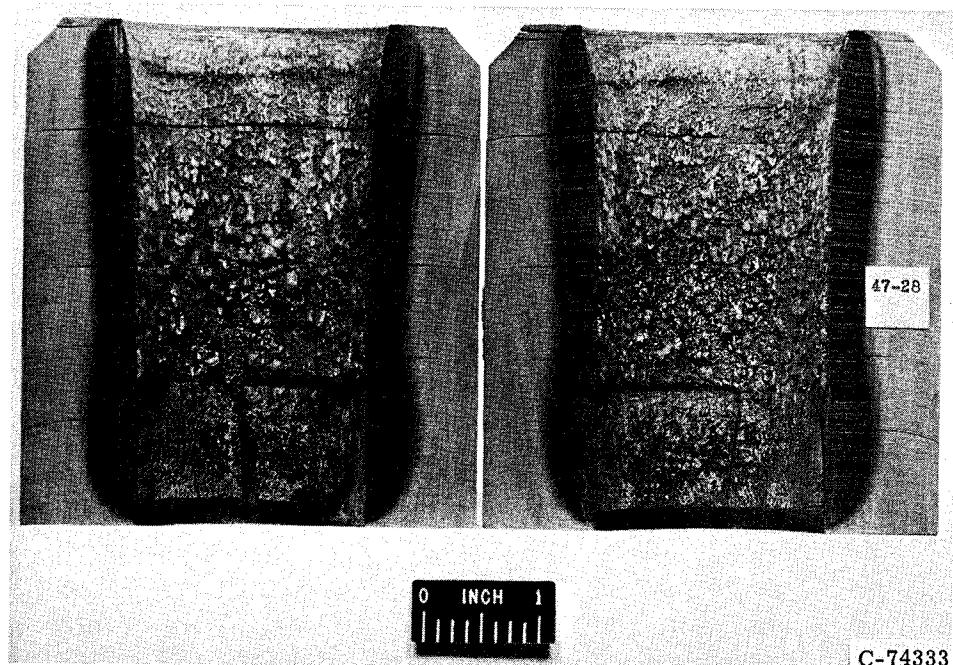
(1) Insert 1; configuration A; injector 11; characteristic length, 65; no coating

Material	Form	Manufacturer	Additional layer
Insert		Pyrolyzed graphite phenolic with SiC-Si additive	Cloth (90° to centerline)	Chance-Vought	None
Envelope		Silica phenolic (MX 2641)	Cloth (90° to centerline)	Fiberite	0.25-in.-thick stainless-steel shell
Run	Chamber pressure, P_c , psia	Oxidant-fuel ratio, O/F	Run time, sec	Total change in effective throat radius, ΔR , in.	Remarks
22	106.6 to 101.6	1.92	60.2	0.0065	Timed shutdown
28	101.8 to 86.9	2.04	43.3	.060	Low chamber pressure shutdown
37	105.7 to 85.7	2.16	34.1	.206	Low chamber pressure shutdown
			137.6

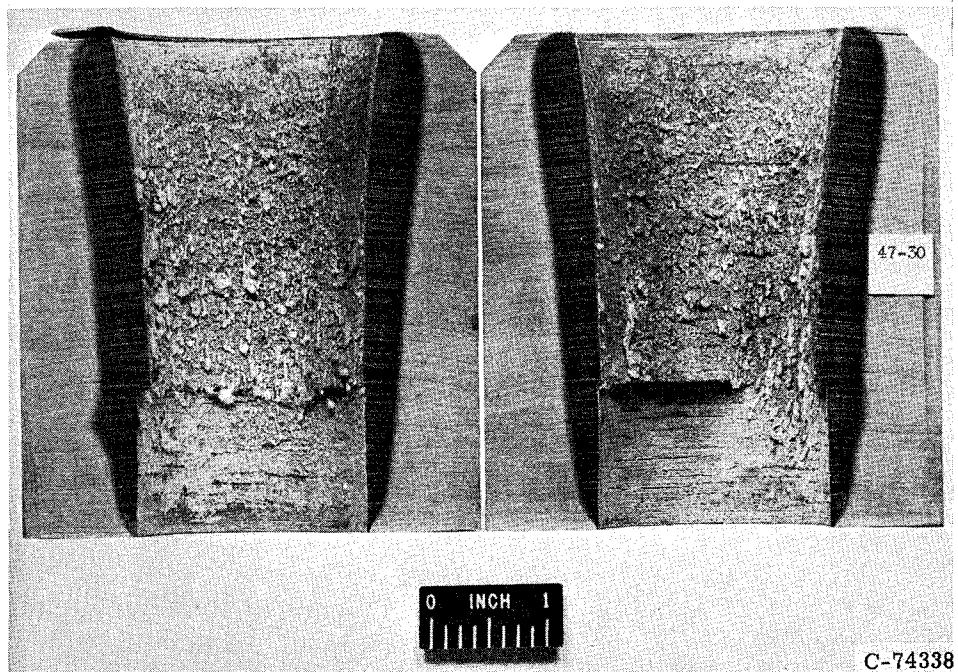
(2) Insert 2; configuration B; injector 11; characteristic length, 67; no coating

Material	Form	Manufacturer	Additional layer	
Insert	Precharred silica epoxy	C1554-48 cloth (90° to centerline)	Avco Corp	None	
Envelope	Silica phenolic MX 2641	Cloth (90° to centerline)	Haveg	0.250-in.-thick stainless-steel shell	
Run	Chamber pressure, P_c , psia	Oxidant-fuel ratio, O/F	Run time, sec	Total change in effective throat radius, ΔR , in.	Remarks
32	106.9 to 87.6	1.97	49.7	0.0755	Low chamber pres- sure shutdown
44	101.0 to 90.0	2.38	79.8 129.5	.1505 (calc)	Low chamber pres- sure shutdown

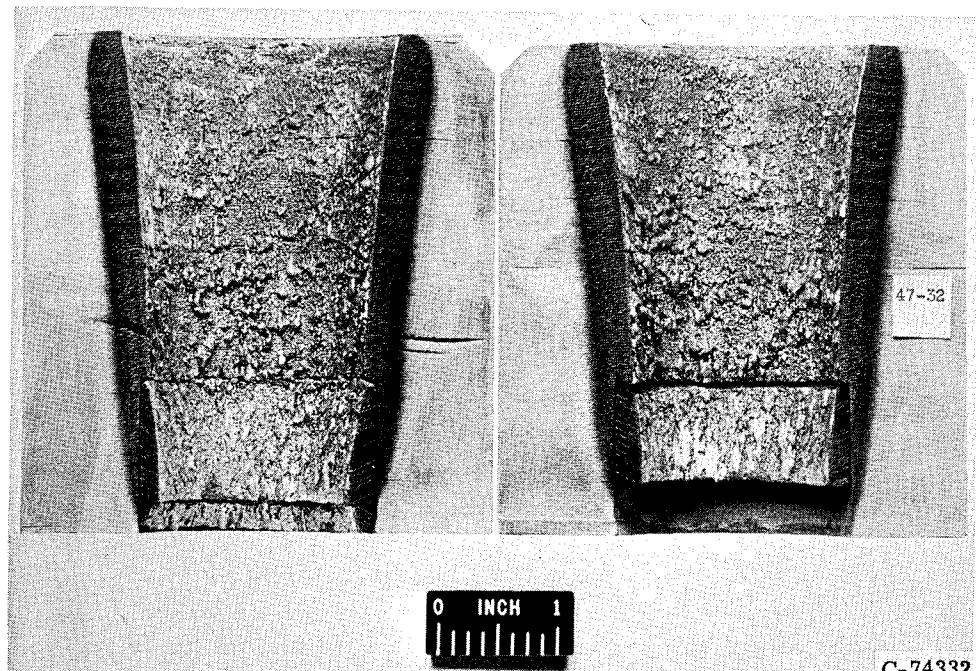
(3) Insert 3; configuration B; injector 11; characteristic length, 67; no coating

Material	Form		Manufacturer	Additional layer
Insert		Precharred silica epoxy	C1554-48 cloth (60° to centerline)		Avco Corp	None
Envelope		Silica phenolic MX 2641	Cloth (90° to centerline)		Haveg	0.25-in.-thick stainless-steel shell
Run	Chamber pressure, P_c , psia	Oxidant-fuel ratio, O/F	Run time, sec	Total change in effective throat radius, ΔR , in.	Remarks	
33	106.2 to 86.8	1.97	43.7	0.0535	Low chamber pressure shutdown	
49	103.0 to 83.3	1.93	39.5 83.2	.173 (calc)	Low chamber pressure shutdown

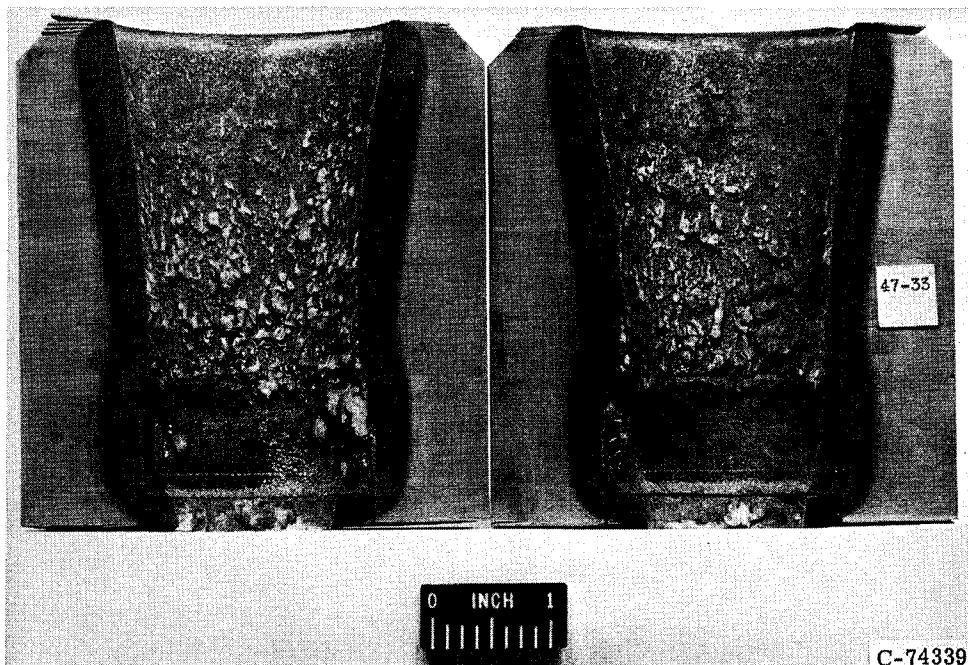
(4) Insert 4; configuration B; injector 11; characteristic length, 67; no coating

Material	Form	Manufacturer	Additional layer
Insert	Graphite phenolic with ZrC-SiC powder additive		Cloth (90° to centerline)	Chance-Vought	None
Envelope	Silica phenolic (MX 2641)		Cloth (90° to centerline)	Fiberite	0.250-in.-thick stainless-steel shell
Run	Chamber pressure, P_c , psia	Oxidant-fuel ratio, O/F	Run time, sec	Total change in effective throat radius, ΔR , in.	Remarks
38	119.0 to 85.6	2.24	57.0	0.1465 (calc)	Low chamber pressure shutdown

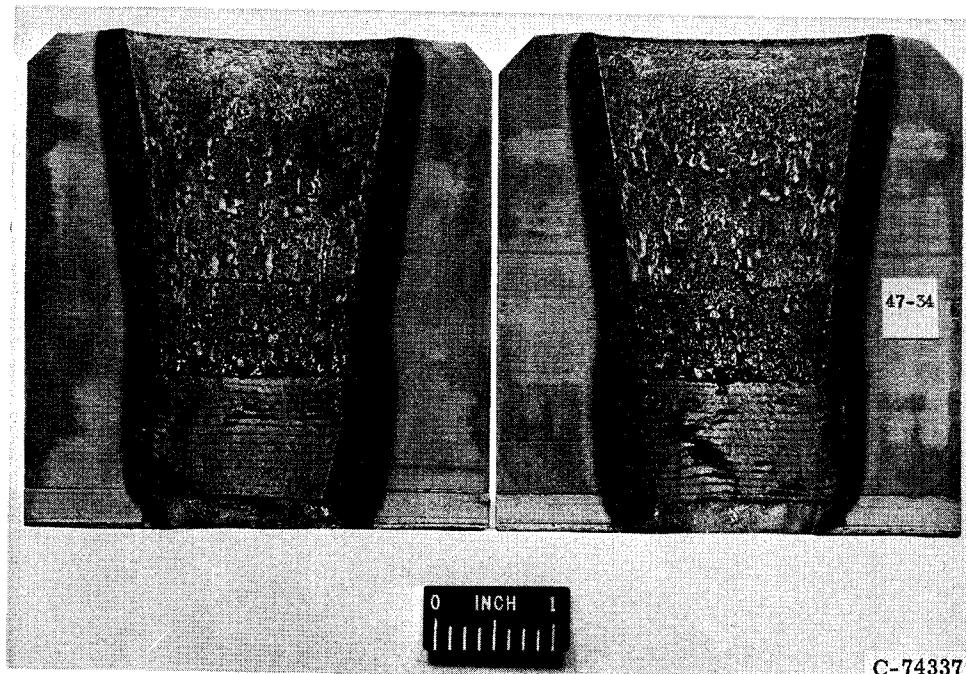
(5) Insert 5; configuration B; injector 11; characteristic length, 67; no coating

Material	Form	Manufacturer	Additional layer
Insert	Graphite phenolic with Hf-Si powder additive		Cloth (90° to centerline)	Chance-Vought	None
Insert	Envelope	Silica phenolic (MX 2641)	Cloth (90° to centerline)	Fiberite	0.25-in.-thick stainless-steel shell
Run	Chamber pressure, P_c , psia	Oxidant-fuel ratio, O/F	Run time, sec	Total change in effective throat radius, ΔR , in.	Remarks
46	103.5 to 102.6	1.54	5.5	-----	Timer shutdown for facility check
47	106.6 to 85.1	1.71	39.8 45.3	0.080	Low chamber pressure shutdown

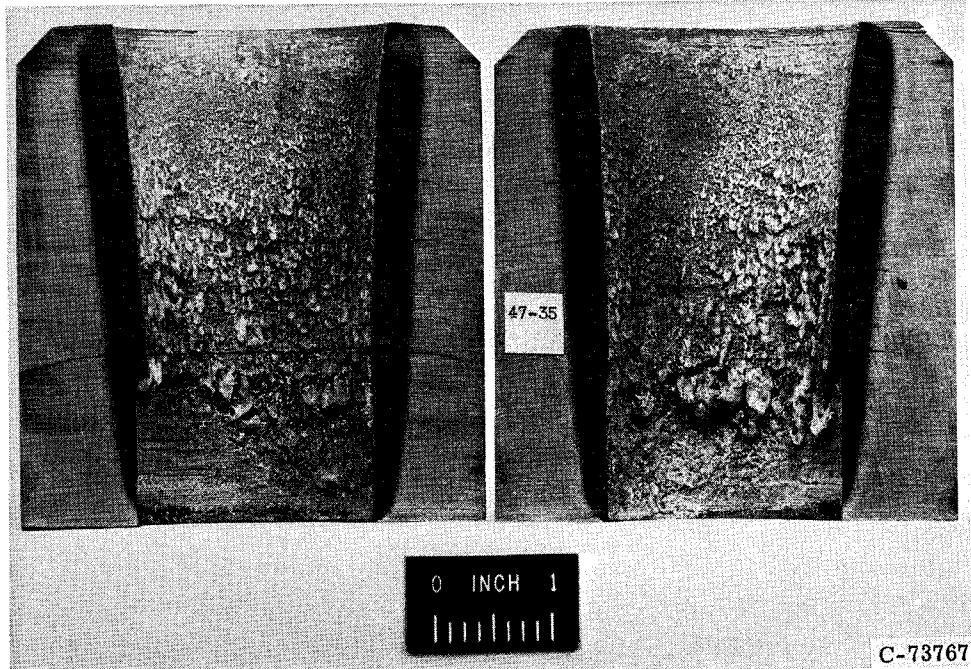
(6) Insert 6; configuration C; injector 11; characteristic length, 67; no coating

Material	Form		Manufacturer	Additional layer
Insert	Graphite phenolic with Hf-Si powder additive		Cloth (90° to centerline)		Chance-Vought	None
Envelope	Silica phenolic (MX 2641)		Cloth (90° to centerline)		Fiberite	0.25-in.-thick stainless-steel shell
Run	Chamber pressure, P_c , psia	Oxidant-fuel ratio, O/F	Run time, sec	Total change in effective throat radius, ΔR , in.	Remarks	
24	102.0 to 86.6	1.74	60.1	0.0645	Low chamber pressure shutdown	
29	105.1 to 89.8	2.51	26.2	.1345	Low chamber pressure shutdown	
			86.3

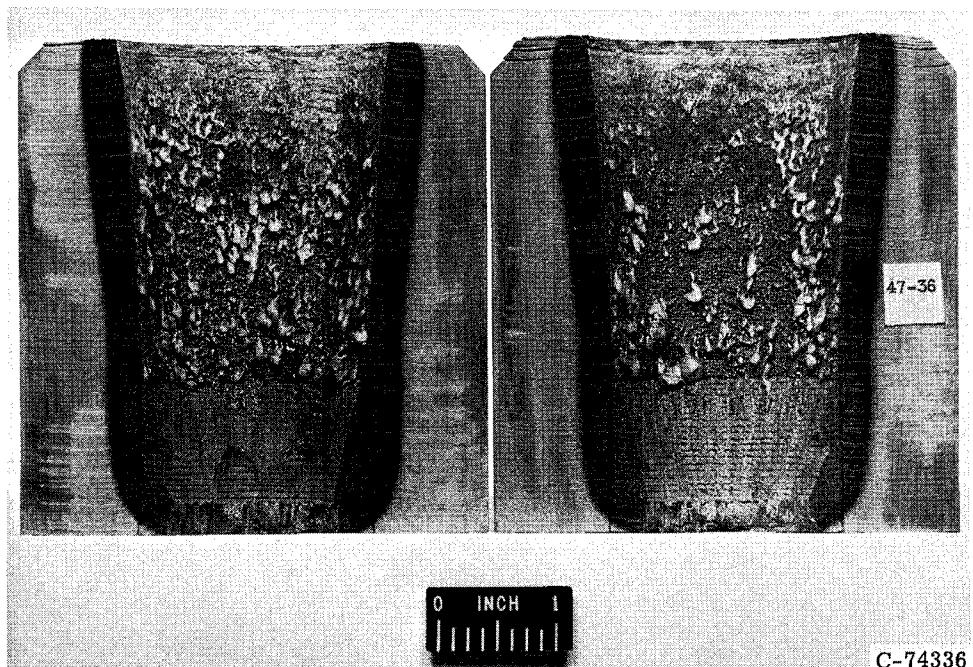
(7) Insert 7; configuration B; injector 11; characteristic length, 67; no coating

Material	Form	Manufacturer	Additional layer
Insert		Graphite-phenolic with TaO_2 -Si powder additive	Cloth (90° to centerline)	Chance-Vought	None
Envelope		Silica phenolic (MX 2641)	Cloth (90° to centerline)	Fiberite	0.25-in.-thick stainless-steel shell
Run	Chamber pressure, P_c , psia	Oxidant-fuel ratio, O/F	Run time, sec	Total change in effective throat radius, ΔR , in.	Remarks
48	98.4 to 85.0	1.78	53.0	0.0685	Low chamber pressure shutdown

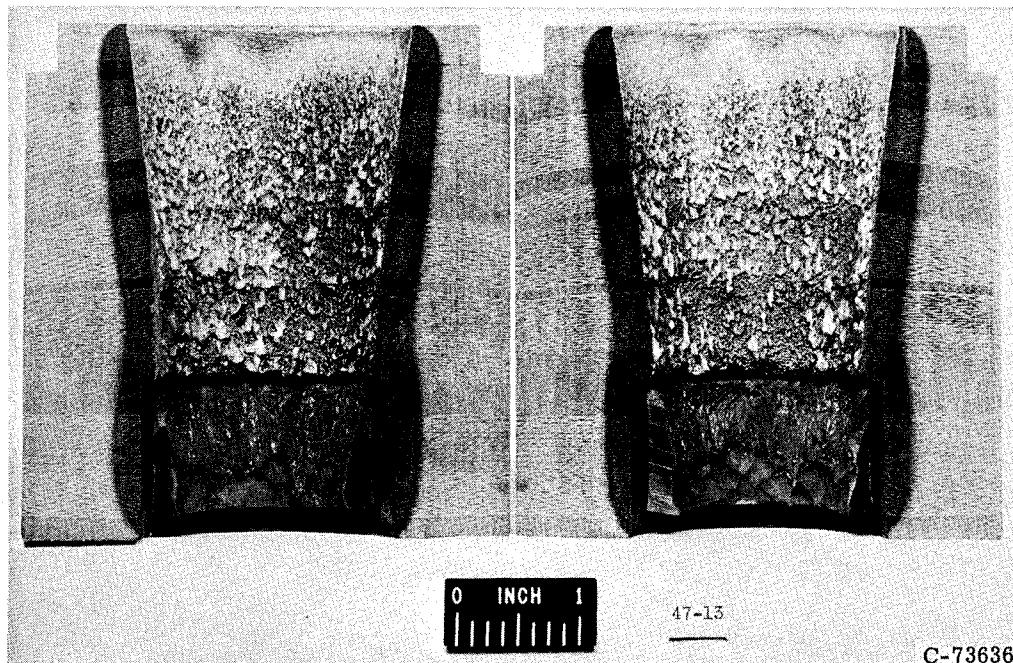
(8) Insert 8; configuration C; injector 11; characteristic length, 67; no coating

Material	Form	Manufacturer	Additional layer
Insert	50 WC - 50 Ag	WC powder in Ag matrix	Mallory	0.085-in.-thick Rokide Z on insert outside diameter
Envelope	Silica phenolic (MX 2641)	Cloth (90° to centerline)	Haveg	0.25-in.-thick stainless-steel shell
Run	Chamber pressure, P_c , psia	Oxidant-fuel ratio, O/F	Run time, sec	Total change in effective throat radius, ΔR , in.
410	108.5 to 90.0	2.20	39.0	0.0925 (calc)
				Insert pitted, Rokide gone

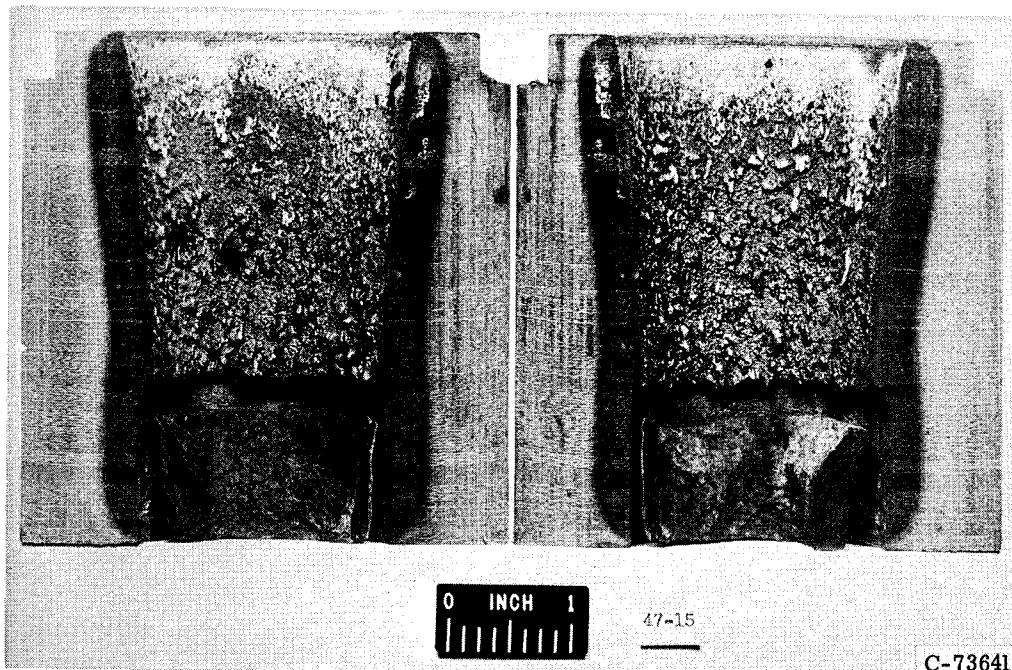
(9) Insert 9; configuration C; injector 11; characteristic length, 67; no coating

Material	Form	Manufacturer	Additional layer
Insert		57 WC - 43 Cu	WC powder in Cu matrix	Mallory	0.042-in.-thick Rokide Z
Envelope		Silica phenolic (MX 2641)	Cloth (90° to centerline)	Haveg	0.25-in.-thick stainless-steel shell
Run	Chamber pressure, P_c , psia	Oxidant-fuel ratio, O/F	Run time, sec	Total change in effective throat radius, ΔR , in.	Remarks
8	104.0 to 90.7	1.89	60.0	0.048 (calc)	Melting and cracking

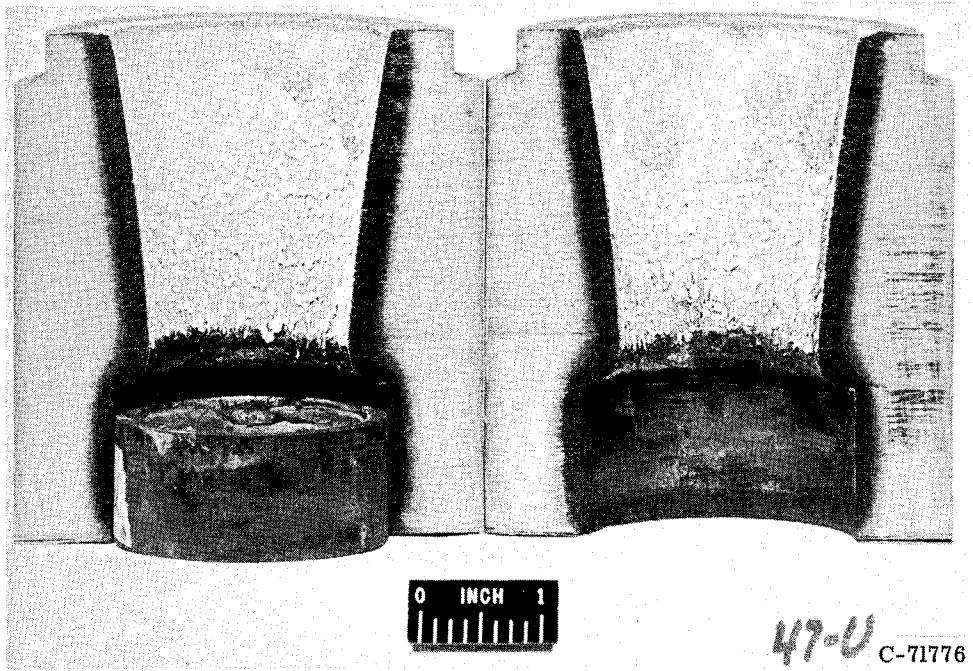
(10) Insert 10; configuration B; injector 11; characteristic length, 67; no coating

The titanium diboride with zirconium dioxide filler (insert 10) failed by oxidation of the titanium diboride, as shown by X-ray analysis of the reaction products. The two carbide-powder - organic-resin-bonded materials (inserts 11 and 12) failed by cracking in spite of a molybdenum reinforcing band. The primary mode of failure, however, was erosion due to loss of particles as the organic binder was removed during firing. The structure remaining after loss of the binder was not strong enough to withstand the shear forces in the rocket nozzle environment.

Material	Form		Manufacturer	Additional layer
Insert		TiB ₂ with ZrO ₂ filler			Caloboric	0.040-in.-thick Rokide Z, 0.125-in.-thick stainless-steel sleeve with 0.005 interference fit
Envelope		Silica phenolic (MX 2641)	Tape (90° to centerline)		Haveg	0.25-in.-thick stainless-steel shell
Run	Chamber pressure, P _c , psia	Oxidant-fuel ratio, O/F	Run time, sec	Total change in effective throat radius, ΔR, in.	Remarks	
341	101 to 93	2.24	21.9	0.0465	Low chamber pressure shutdown	
360	101 to 92	2.23	19.2	.1015	Low chamber pressure shutdown	
366	97.5 to 92	2.20	13.6 54.7	.1345	Low chamber pressure shutdown

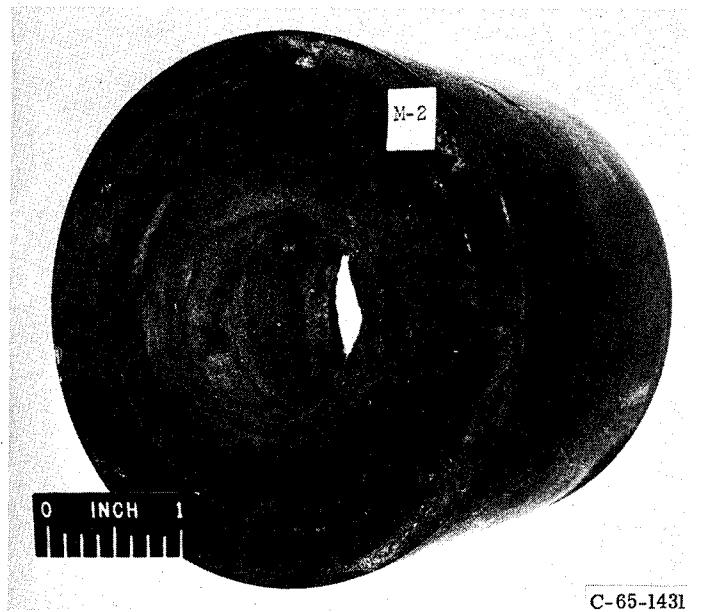
(12) Insert 12; configuration D; injector 11; characteristic length, 66: no coating

Material	Form	Manufacturer	Additional layer
Insert	HfC-SiC coated graphite powder	Pressed and sintered	Magnesium Aerospace	0.125-in.-thick Mo sleeve with 0.005 interference fit	
Envelope	Silica phenolic	Cloth (90° to centerline)	Magnesium Aerospace	0.325-in.-thick nylon sleeve, 0.25-in.-thick stainless-steel shell	
Run	Chamber pressure, P_c , psia	Oxidant-fuel ratio, O/F	Run time, sec	Total change in effective throat radius, ΔR , in.	Remarks
328	101 to 91	1.68	33.8	0.031	Circumferential crack 1/4 in. from exit plane
352	102.1	1.84	7.1	.0575	Leakage abort
369	-----	----	2.9	-----	Low chamber pressure shutdown
370	96.5 to 91.0	2.20	10.8	.1025	Low chamber pressure shutdown, axial cracks
377	96.5 to 91.0	2.18	13.4	.1565	Low chamber pressure shutdown, axial cracks
			68.0

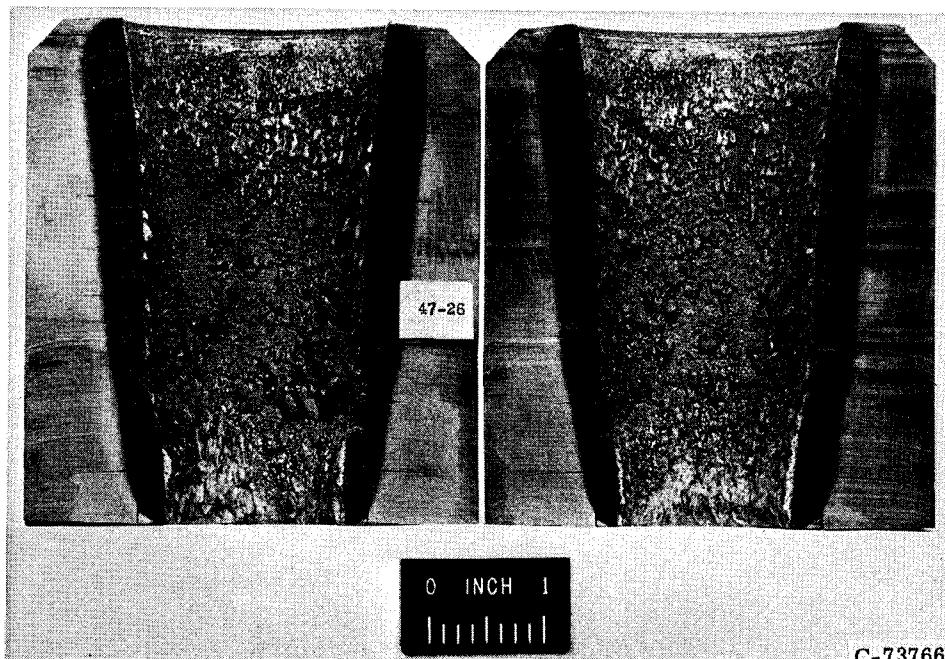
(13) Insert 13; configuration B; injector 11; characteristic length, 67; no coating

Material		Form		Manufacturer	Additional layer
Insert	80 SiO ₂ - 20 C		Powder sintered and pressed		Avco Corp	None
Envelope	Silica phenolic (MX 2641)		Cloth (90° to centerline)		Haveg	0.25-in.-thick stainless-steel shell
Run	Chamber pressure, P _c , psia	Oxidant-fuel ratio, O/F	Run time, sec	Total change in effective throat radius, ΔR, in.	Remarks	
21	102.7 to 89.3	2.40	56.1	0.0395	Low chamber pressure shutdown	
30	97.1 to 85.5	2.26	53.1 109.2	.112	Low chamber pressure shutdown

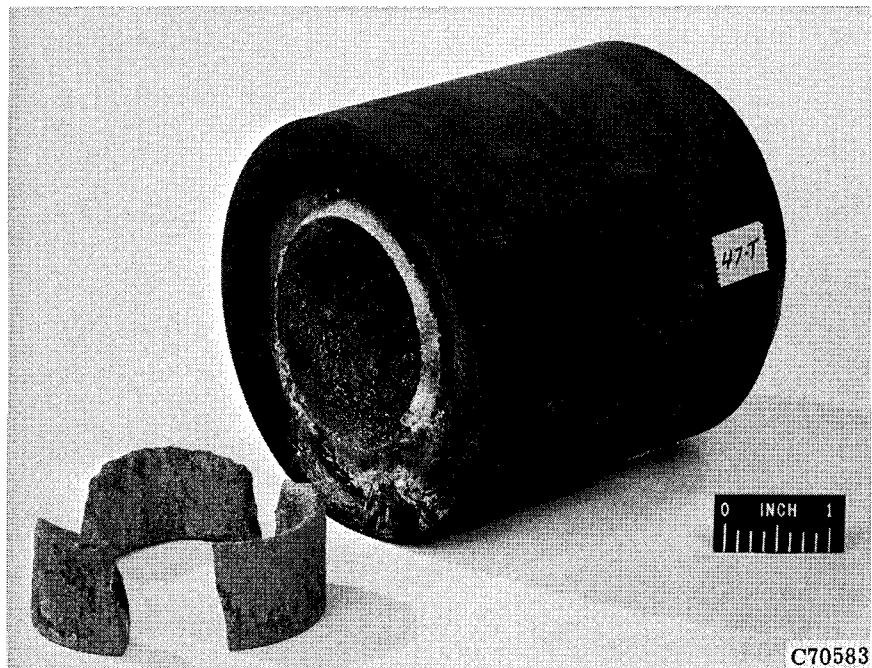
(14) Insert 14; configuration B; injector 11; characteristic length, 67; no coating

Material		Form		Manufacturer	Additional layer
Insert		GRB silicon carbide (64 SiC - 33 C - 3 Si)		Carborundum	0.04-in.-thick Rokide Z on in- sert outside diameter
Envelope		Silica phenolic (MX 2641)		Haveg	0.25-in.-thick stainless-steel shell
Run	Chamber pressure, P_c , psia	Oxidant-fuel ratio, O/F	Run time, sec	Total change in effective throat radius, ΔR , in.	Remarks
297	105.5 to 103	1.71	60.3	0.0105	Timed shutdown, no apparent cracks
298	100.5 to 95	1.70	75.7 136.0	.037 (calc)	Cracked into three pieces

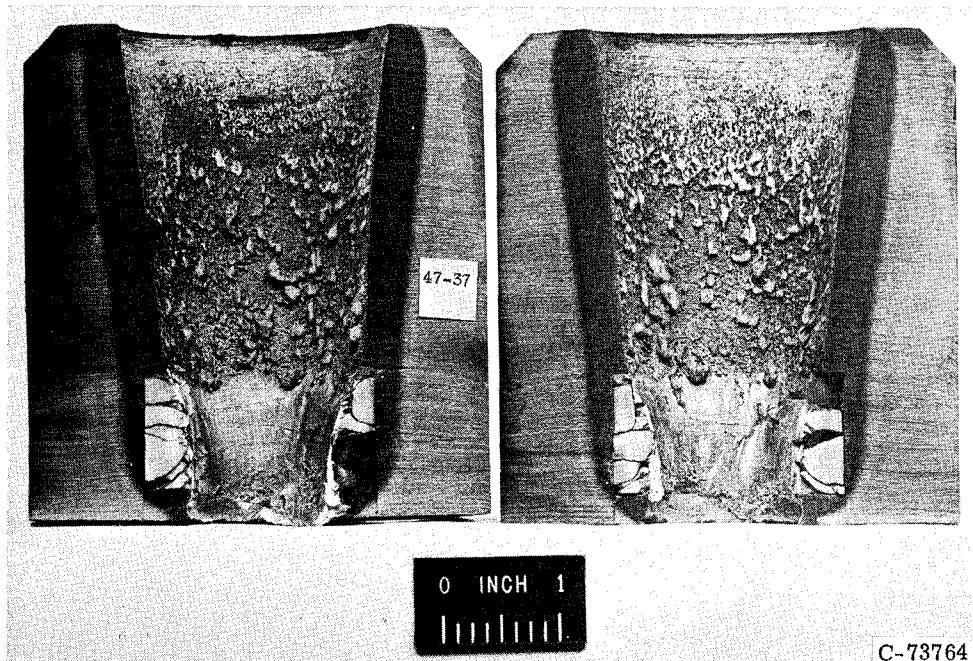
(15) Insert 15; configuration C; injector 11; characteristic length, 67; no coating

Material	Form	Manufacturer	Additional layer
Insert		65 ZrO ₂ - 35 SiO ₂	Hot pressed	Aerospace Corp	None
Envelope		Silica phenolic (MX 2641)	Cloth (90° to centerline)	Haveg	0.25-in.-thick stainless-steel shell
Run	Chamber pressure, P _c , psia	Oxidant-fuel ratio, O/F	Run time, sec	Total change in effective throat radius, ΔR, in.	Remarks
25	92.8 to 94.1	1.98	60.1	-0.033	Timer shutdown; cracks and local erosion

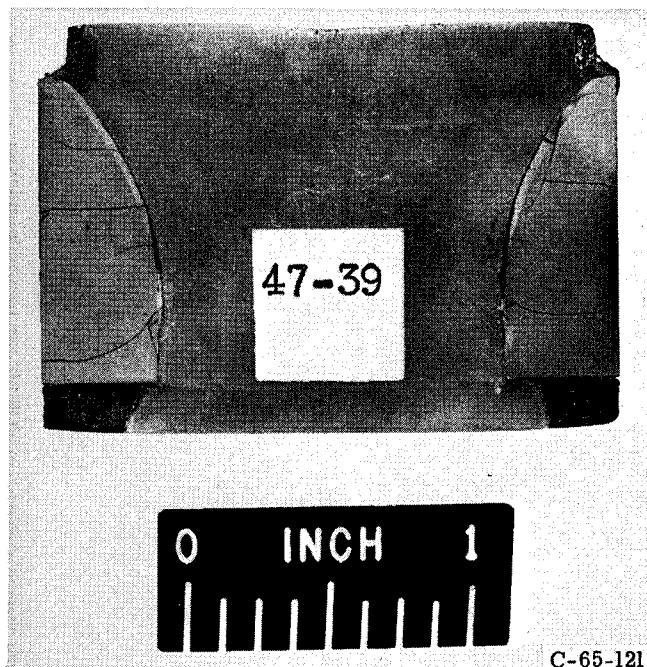
(16) Insert 16; configuration C; injector 11; characteristic length, 67; no coating

Material		Form		Manufacturer	Additional layer
Insert	85 BeO - 15 SiC		Hot pressed		Aerospace Corp	None
Envelope	Silica phenolic (MX 2641)		Cloth (90° to centerline)		Haveg	0.25-in.-thick stainless-steel shell
Run	Chamber pressure, P_c , psia		Oxidant-fuel ratio, O/F	Run time, sec	Total change in effective throat radius, ΔR , in.	Remarks
27	101.1 to 97.0		2.14	60.4	-0.0075	Timer shutdown; circumferential and longitudinal cracks

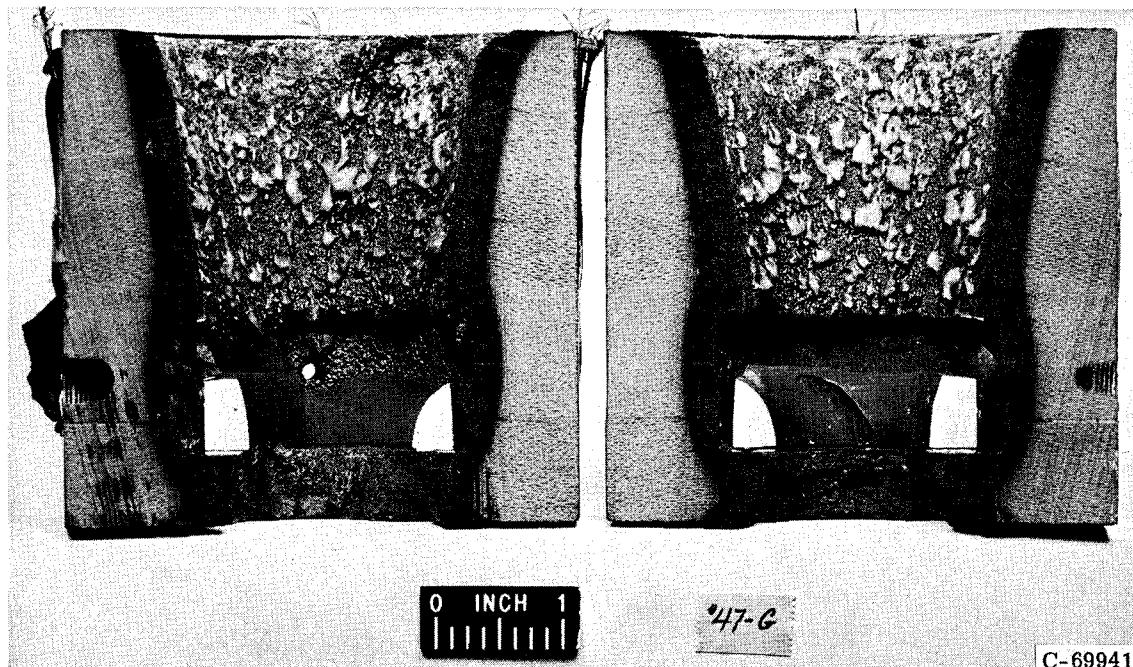
(17) Insert 17; configuration C; injector 12; characteristic length, 50; no coating

Material	Form	Manufacturer	Additional layer
Insert		BN		Carborundum	0.125-in.-thick stainless-steel sleeve with 0.005 interference fit
Envelope		Silica phenolic (MX 2641)	Tape (90° to centerline)	Haveg	None
Run	Chamber pressure, P_c , psia	Oxidant-fuel ratio, O/F	Run time, sec	Total change in effective throat radius, ΔR , in.	Remarks
204	107 to 103.5	1.96	26.0	-----	Timed shutdown, no cracks
205	102 to 90	2.02	42.6	0.0645	Low chamber pressure shutdown
			68.6

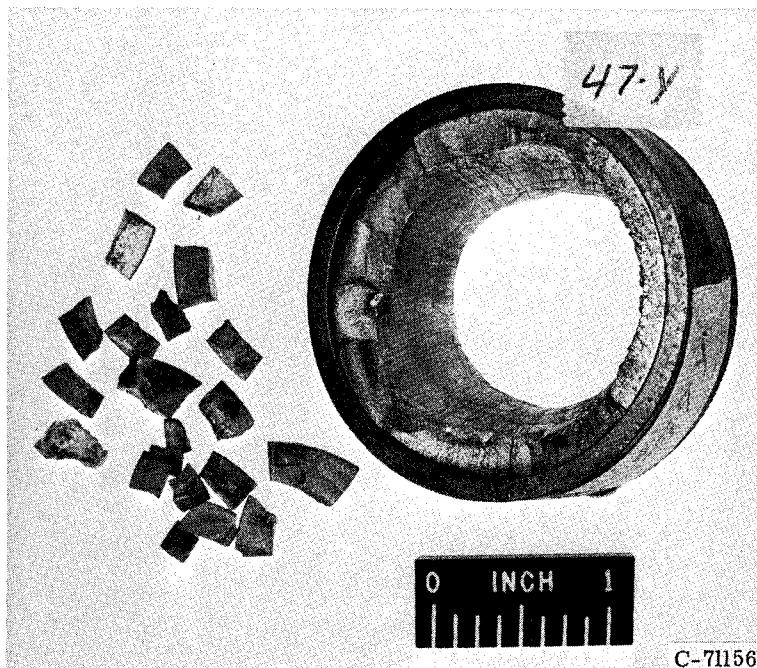
(18) Insert 15; configuration A; injector 11; characteristic length, 65; no coating

Material	Form	Manufacturer	Additional layer
Insert		Al_2O_3		General Electric	0.125-in.-thick stainless-steel sleeve with 0.0005 interference fit
Envelope		Silica phenolic (MX 2641)	Tape (90° to centerline)	Haveg	0.25-in.-thick stainless-steel sleeve
Run	Chamber pressure, P_c , psia	Oxidant-fuel ratio, O/F	Run time, sec	Total change in effective throat radius, ΔR , in.	Remarks
343	104 to 95	2.29	60.3	0.023	Timed shutdown; local erosion and severe cracking

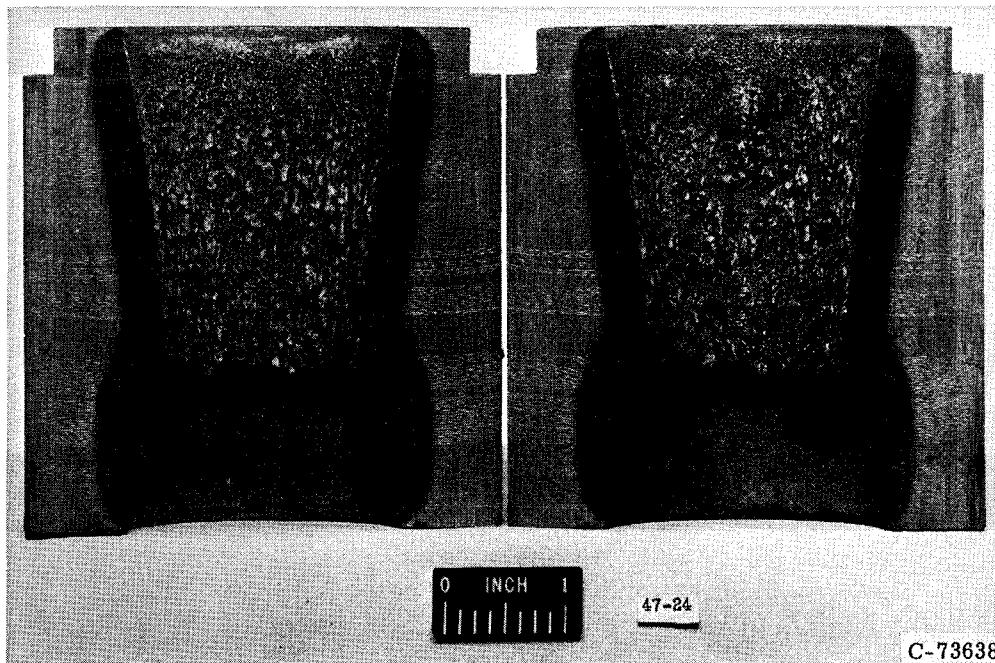
(20) Insert 20; configuration B; injector 11; characteristic length, 67; no coating

Material		Form		Manufacturer	Additional layer
Insert		ZrB ₂		Norton	0.125-in.-thick stainless-steel sleeve with 0.005 interference fit
Envelope		Silica phenolic (MX 2641)		Fiberite	0.25-in.-thick stainless-steel shell
Run	Chamber pressure, P _c , psia	Oxidant-fuel ratio, O/F	Run time, sec	Total change in effective throat radius, ΔR, in.	Remarks
7	98.6 to 91.7	1.99	49.7	0.028 (calc)	Low chamber pressure shutdown; lost insert
